New system of repair and reinforcement of “violin joists”, with stainless steel

Specifically, they are ceramic joists slabs in a basement built in the 50s, with a type of joist known as “VIGUETA VIOLÍN”.

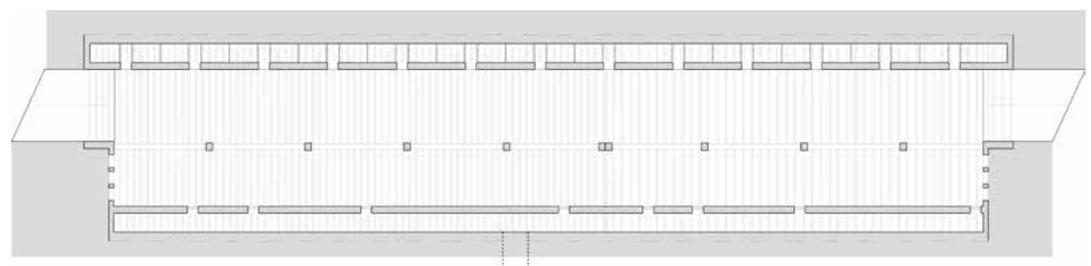
TA02 A BASEMENT FLOOR

The data collection allowed us to observe the structural configuration of the basement. The general structure of the building is solved by pillars and beams hanging from reinforced concrete. Although in the basement, besides the presence of a central row of pillars and beams, appear around the perimeter masonry walls, on the beams and walls they support the ceramic joists that form the resistant base of the slab package. (See plant TA02 A) After the visits, we could observe the presence of damages type fissures and cracks, characteristic of the reinforcement oxidation process.

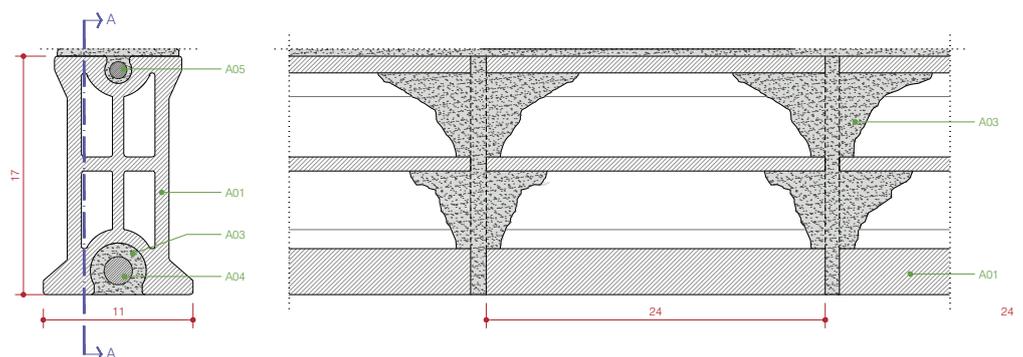
TD02 B TYPOLOGY of original joist

In the SAMPLING COLLECTION section, we will comment on what was found in these repairs. As we can observe in the constructive detail, this type of joist, called “Violin”, is very unique. Due to the geometry of the ceramic piece in which the joist reinforcement is housed, it is unfeasible physically to clean the steel bars around their perimeter, disabling traditional repair actions.

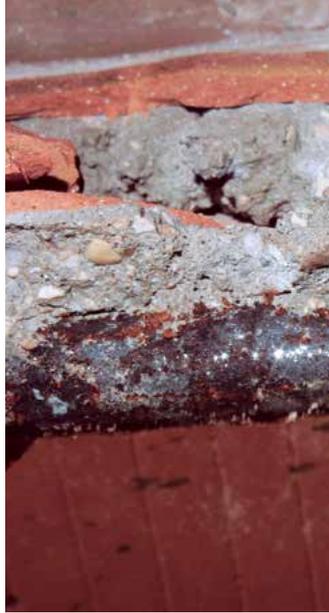
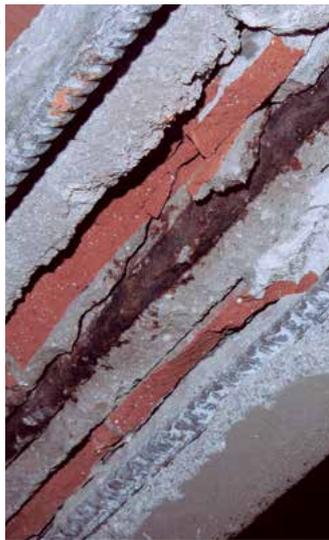
Sampling collection

In order to understand more clearly the structural system of the basement and the configuration of the repaired joists, a series of testing were carried out in the different types of action found. In the first type of repair, the cracks are located in the centre of the lower face of the beam, indicating the oxidation of the original reinforcement. After the sampling collection, we could see the attempt to clean and protect the carbon steel round bar of origin, observing the blue colour protection in the photos. In the second type of repair, on the underside of the joist, two cracks appear in parallel, indicating the presence of 2 bars added as a supplement to the original joist. In both cases, following the sequence of photos, the constructive detail referring to the type of repair is attached.

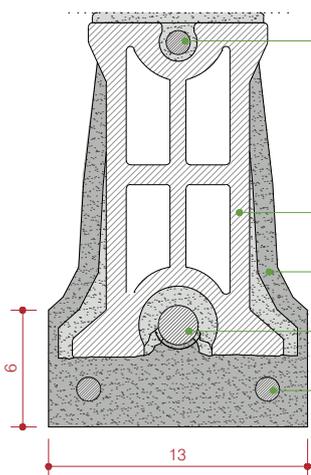
FORMER REPAIR

In addition to the original joists (see detail TD02 B), we found 2 types of repairs made years ago, and both types accumulated most of the fissures and cracks observed.
