Rehabilitation of the rear of the altar of Burgos Cathedral

Stainless steel protects our cultural heritage

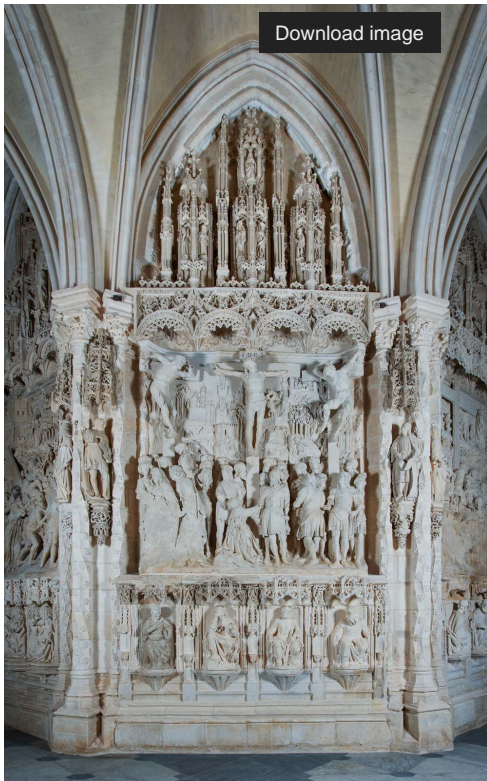
The porosity of the type of the stone facilitated leakage with high content of salt, with the consequent progressive degradation over the years. The project required the dismantling of the two of the fragile and huge main reliefs because of the cracking.

1. Some damaged sculptural ensembles were dismantled and desalted. Those not dismantled, were cleaned with photonic laser techniques.
2. Construction of an isolation system to avoid filtrations.
3. Restoration and consolidation of some detached pieces and the reinforcing of some blocks of stone.

Stainless steel contributed again to guarantee durability and structural consolidation of the reliefs.
