New repair system for slab front with stainless steel

3. CASE STUDY

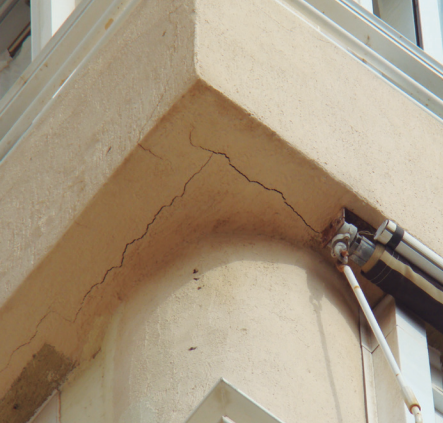
Figure 1: Fissures on the lower face of the slab front

In the reality of a structure of reinforced concrete affected, we find that the damage is practically never homogeneous, but varies in scope and intensity within a single element of concrete, and among some elements and others of similar characteristics. [Figures 1, 2, 3]

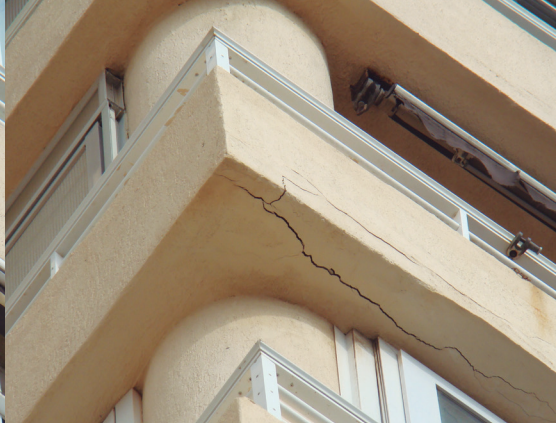
Figure 2: Fissures on the lower face of the slab front

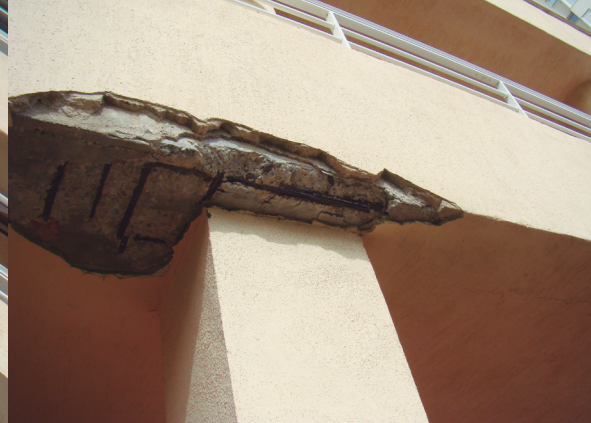
Figure 3: Detail of concrete spalling

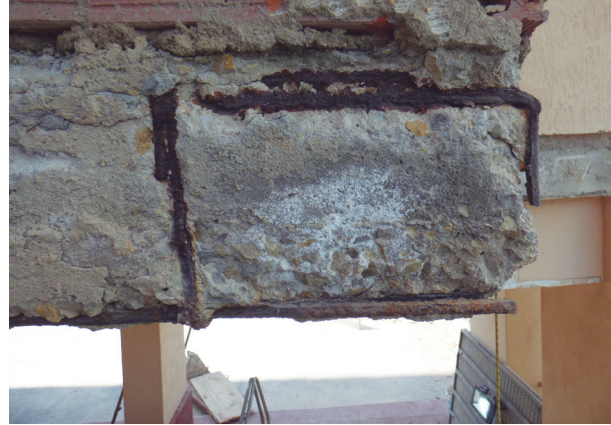
Figure 4: Slab front affected by oxidation

The building object of the repair is located on the beachfront and it is about 35 years old. Concrete elements exposed to marine environment presented high chloride ion content, with values around 2% in content of cement.

Given the original conditions of execution of the building, in addition to the exposure to the marine environment, it is added as a generalized additional factor, the lack of concrete cover in most areas with visible damage, being barely 1 cm.

Because of this fact, we found many areas with unacceptable section loss in the reinforcement bar, which required a repair approach by replacing the necessary affected bars in the most affected areas. [Figures 4, 5, 6]

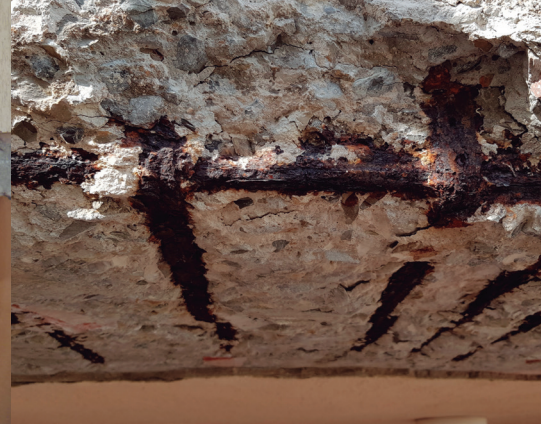
Figure 5: State of the reinforcements after coating removal

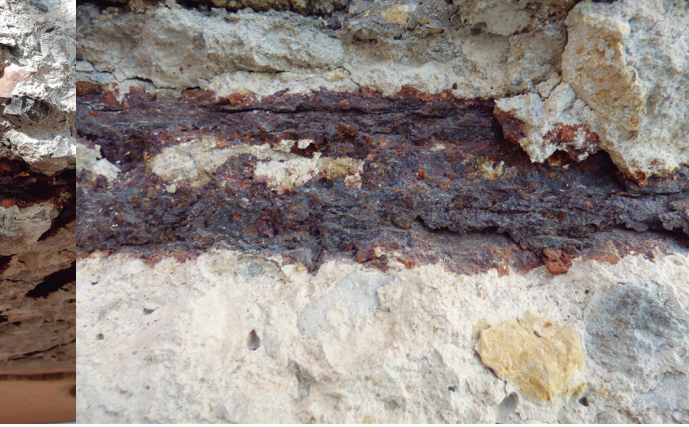
Figura 6: Oxidation remains in concrete

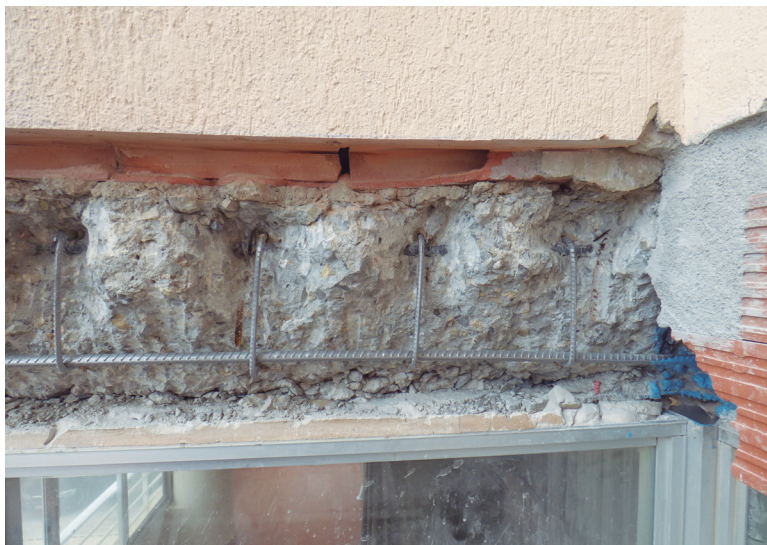
Figure 7: Placing of stainless steel reinforcement

- We can reduce section of the bar to reach the same resistance that we would have with carbon steel bar. [Figure 7]

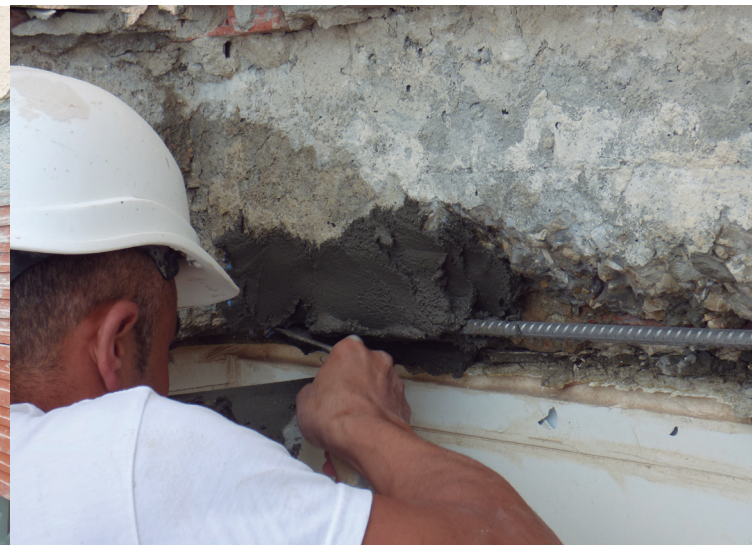
Figure 8: Retaking and regeneration of volume after placement of stainless steel rebar

- We can reduce cover of concrete since we do not need its contribution as corrosion protection of the stainless steel rebar.
- We eliminate practically all the inherent risks in the execution processes, precisely in the most difficult parts to be

repaired. [Figures 8]
