LOCALISED CORROSION OF STAINLESS STEELS – LIMITS AND MECHANISMS

ELECTROCHEMICAL METHOD TO EVALUATE THE STAINLESS STEEL INTERGRANULAR CORROSION RESISTANCE

ATMOSPHERIC STRESS CORROSION CRACKING OF STAINLESS STEELS IN SWIMMING POOL ENVIRONMENTS

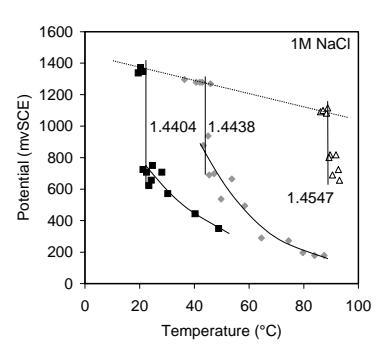
Figure 1. Potentiodynamic determination of CPT from Qvarfort [5] showing abrupt transition between transpassive corrosion and pitting as measurements are made at successively higher temperatures

If variation in chloride concentration is added to Figure1, then a three dimensional diagram illustrated schematically in Figure 2. is obtained. The area closest to the origin represents the "safe" region in which pitting does not occur. Increasing the temperature, potential or chloride concentration increases the risk for pitting until the boundary to the pitting regime is crossed. Strictly speaking, the upper limit in potential may be defined by transpassive corrosion, or dissolution of the passive film, rather than actual localised formation of pits. Introduction of further variables yields a multidimensional volume, which is further complicated when the boundaries for stress corrosion cracking and crevice corrosion are superimposed. For the sake of simplicity, this combined concept is illustrated in two dimensions in Figure 3. This approach is currently being evaluated within the RFCS project CORINOX "Avoiding catastrophic corrosion failure of stainless steels" which will run until 2010.

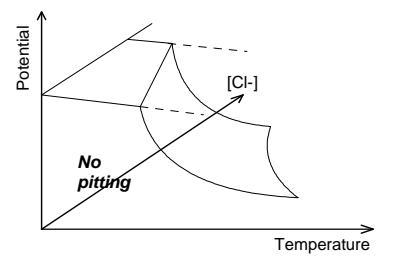
Figure 2. Schematic illustration of the limiting conditions for pitting. The volume close to the origin is that in which no pitting occurs. The upper bound in potential may be defined by transpassive dissolution, the curved line by pitting.

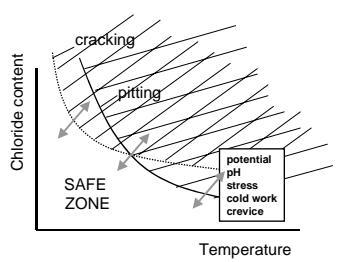
Figure 3. Combined fields for different types of corrosion and effect of experimental variables.

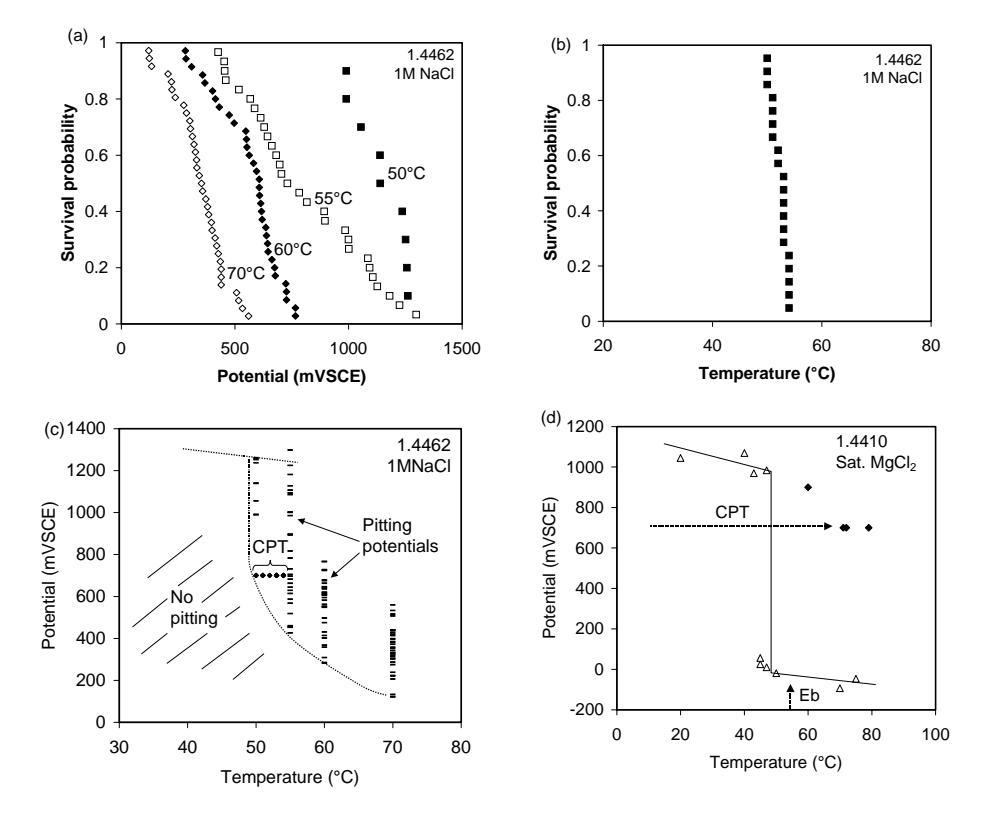
Figure 4. (a) (b) Pitting potentials and critical pitting temperatures for 1.4462 from [7]. (c) Comparison of data from a)and b) shows good agreement in terms of limiting conditions for pitting (d) Data from [10] showing discrepancy between pitting potential and CPT in saturated MgCl₂(pH~3)

A comparison of CPT and pitting potential data in Figure 4c) nevertheless shows good agreement in terms of limiting conditions and definition of the pitting/no pitting boundary for 1.4462 in 1M NaCl. However, this level of agreement is not universal. Figure 4d) shows results from ongoing work in which the same type of comparison has been made for a saturated MgCl₂ solution. This is a rather different type of electrolyte, with a low pH due to the hydrolysis reactions at high metal ion activities [9], and shows less consistent behaviour. There is a large difference which has at least two possible explanations. One is that the CPT measurement is of longer duration, so the passive film has been conditioned or toughened during the slow temperature ramp, the other is that there may be a quasi-active potential region at around 0mV at higher temperatures which can cause attack during pitting potential measurements. Definition of boundary conditions should in this case be based on the most conservative data, in this case pitting potentials. The difference also underlines that the time factor is of importance, and indicates that longer term exposure testing is advisable for firmer definition of pitting boundary conditions.

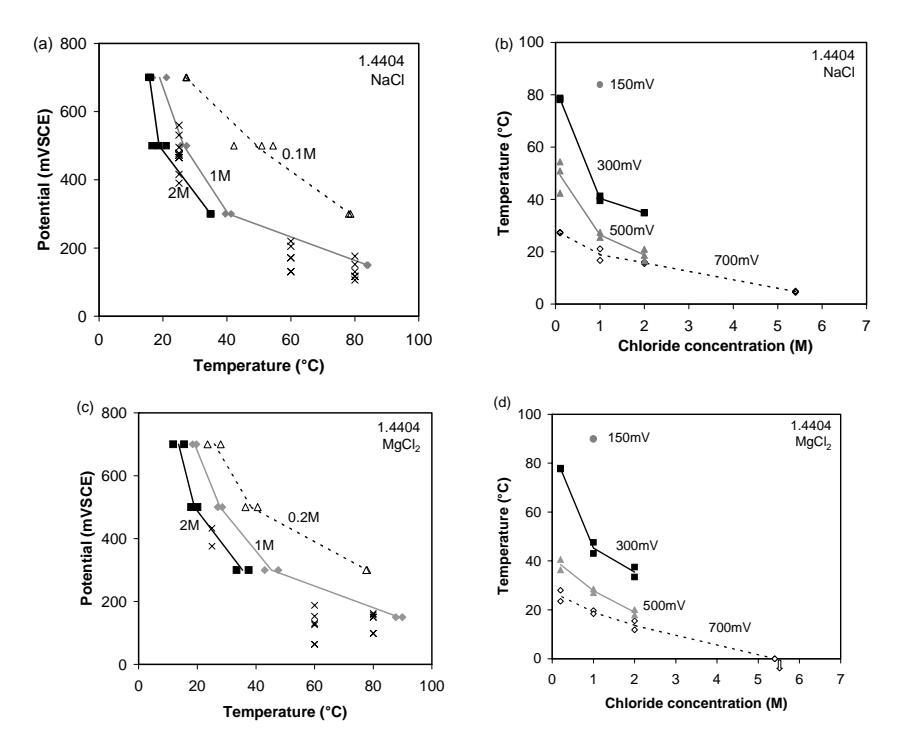
Figure 5. Effect of chloride concentration and potential on CPT for 1.4404 from [11] and comparison with pitting potential measurements in 1M chloride solution (crosses). The solution pH was 5-6 for both $MgCl_2$ and NaCl solutions over the concentration range investigated.

A comprehensive investigation of the critical pitting temperature for 1.4404 has been carried out in MgCl₂ solutions with similar concentrations to NaCl. Figure 5 shows data plotted in two different dimensions of the multicomponent space. The two electrolytes show remarkably good agreement and also the same trends of a shift in the pitting boundary towards the origin by an increase in either concentration or potential. The effect of potential is larger than expected against the background of the concept of a "potential independent CPT" in ASTM G150, for example a drop in the applied potential from 700mV SCE to 300mV SCE increases the CPT from 19°C to 40-45°C . In a similar vein, decreasing the chloride concentration increases the CPT e.g. by ~8°C when the chloride concentration is reduced from 2M to 1M at 500mV. This effect of concentration becomes more pronounced at lower potentials. The mechanistic rationale behind these trends is open to speculation, but it appears reasonable that a higher temperature is required to maintain the high current density necessary for pit propagation in a milder environment.

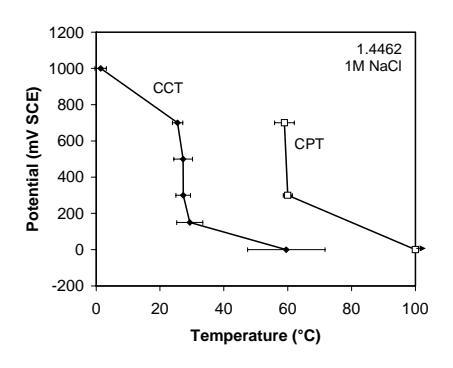
Figure 6. Temperature dependence of CPT and CCT for 1.4462 in 1M NaCl, including some data from [6]. Note that this is a different heat of 1.4462 with a slightly higher CPT than that in Figure 4.

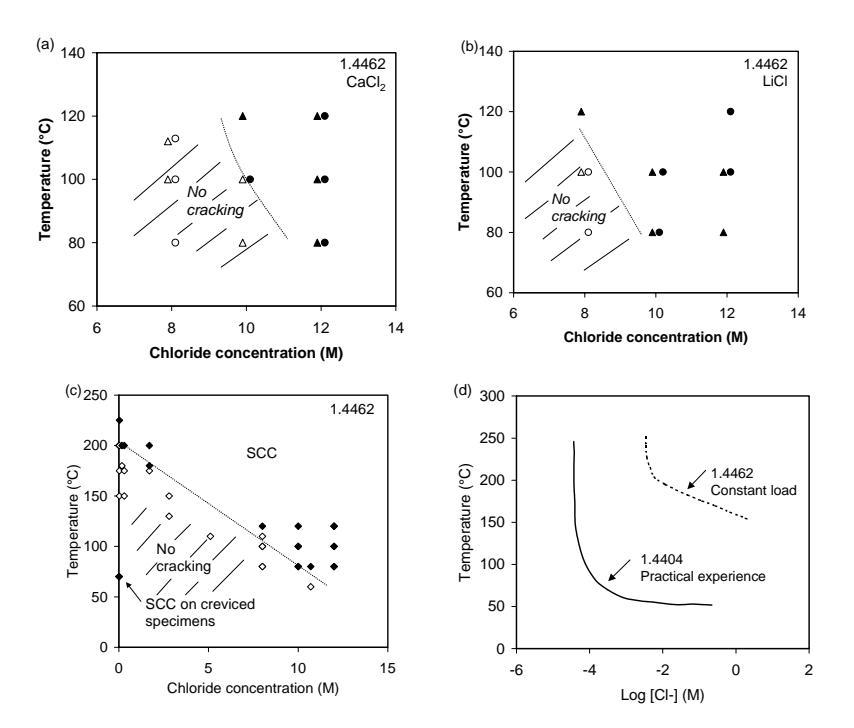
Figure 7a-b) U-bend (triangles) and SSRT results for 1.4462 in CaCl₂ and LiCl from [13] c) Compilation of data from [14] d) Results of practical experience and constant load tests from [15]

The concept of limiting conditions for stress corrosion cracking was introduced in [13] and is illustrated by some examples in Figure 7.

These examples illustrate the same trend as for pitting, namely the "safe zone" at low temperatures and chloride contents, and a fairly well-defined boundary defining the SCC region. The effect of potential remains to be explored, but is liable to be a complicated question, in view of many indications that crack propensity is highest in bands of potential relating to instable passivity. The data underline several important features. Firstly Figure 7a) shows that testing in 10M CaCl₂ at 100°C gave cracking in SSRT but not in U-bend tests. This is a general trend for duplex steels [15], while the opposite situation is observed for austentic steels. The underlying mechanism for this effect is still under investigation, but appears to be related to the mechanical-electrochemical interaction between phases [14] and the larger degree of relaxation in constant deflection in austenitic steels compared to duplex [15]. Secondly, a comparison between Figure 7a) and b) demonstrates that the cation can be significant, with lower SCC boundaries in the more aggressive LiCl solution. Finally Figure 7c) shows the same important point about the detrimental effect of crevices as seen in Figure 4. In this case the SCC temperature decreased by

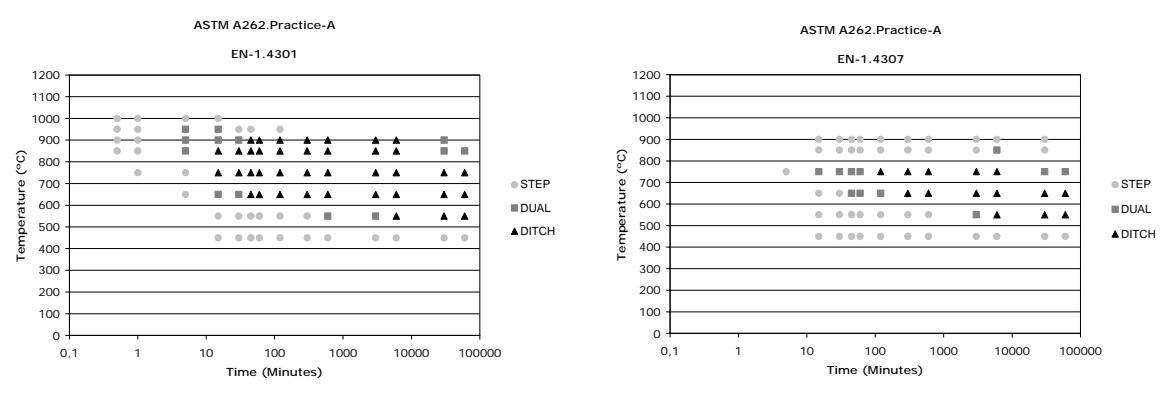
Figure 5. TTS for EN 1.4307, Practice A

The TTS diagrams corresponding to the Practice A are plotted in Figures 4 and 5.

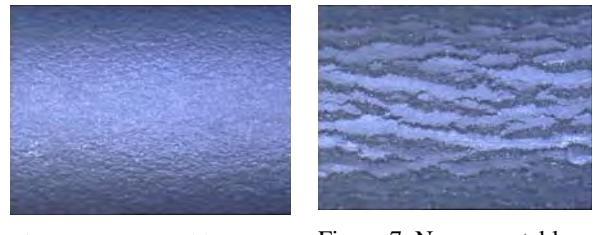
Figure 6. Acceptable

Figure 7. Non acceptable

A 180° bending test was used to determine ACCEPTABLE / NON ACCEPTABLE samples (Figures 6 and 7).

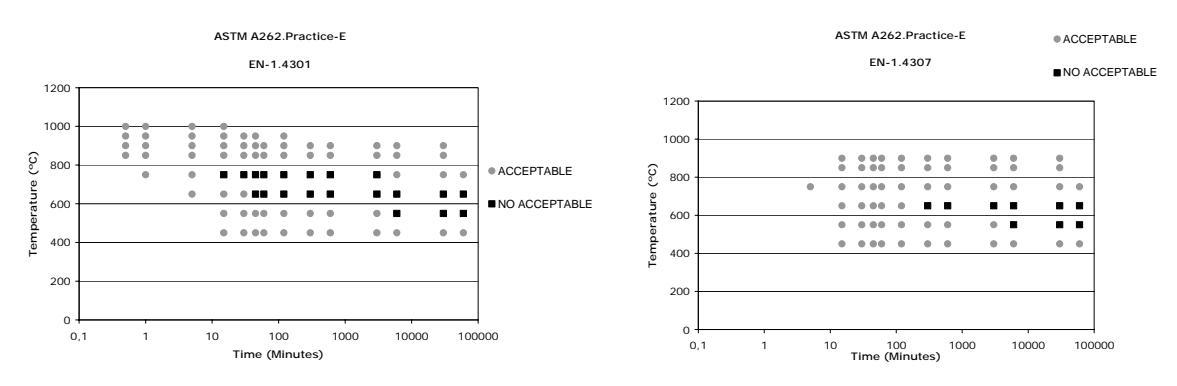
Figure 9. TTS for EN-1.4307, Practice-E

The summary of the tests results are shown in the TTS diagrams in Figures 8 and 9.

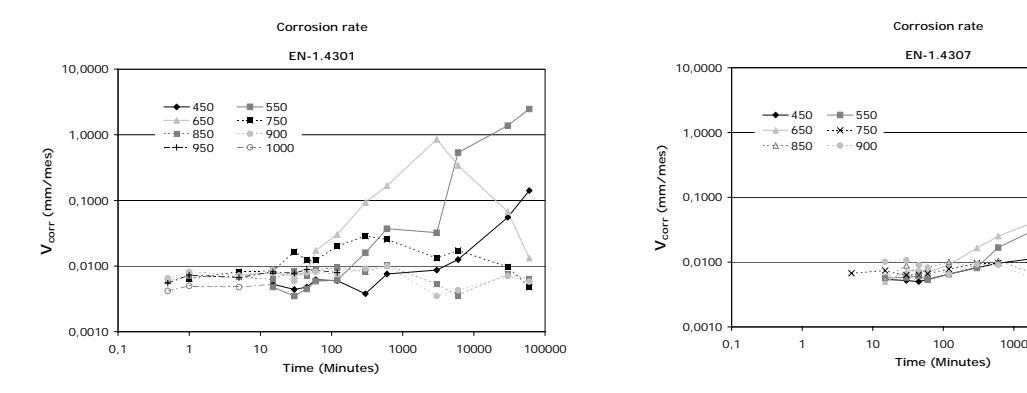
Figure 10. Corrosion rate for-EN 1.4301

Figure 11. Corrosion rate for-EN 1.4307

The corrosion rate for EN 1.4301 and EN 1.4307 is shown in Figure 10 and 11, respectively.

The low temperature thermal treatment shows an increase of the corrosion rate with time. At 650°C a decrease in the corrosion rate with the treatment time is observed beyond 3000 minutes for EN 1.4301 and 6000 minutes for EN 1.4307.

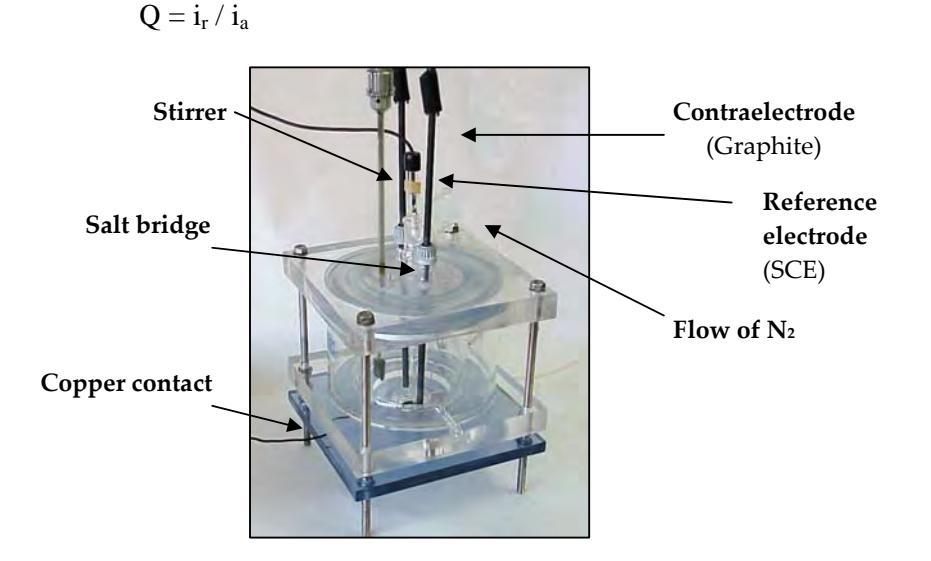
Figure 12. Flat cell

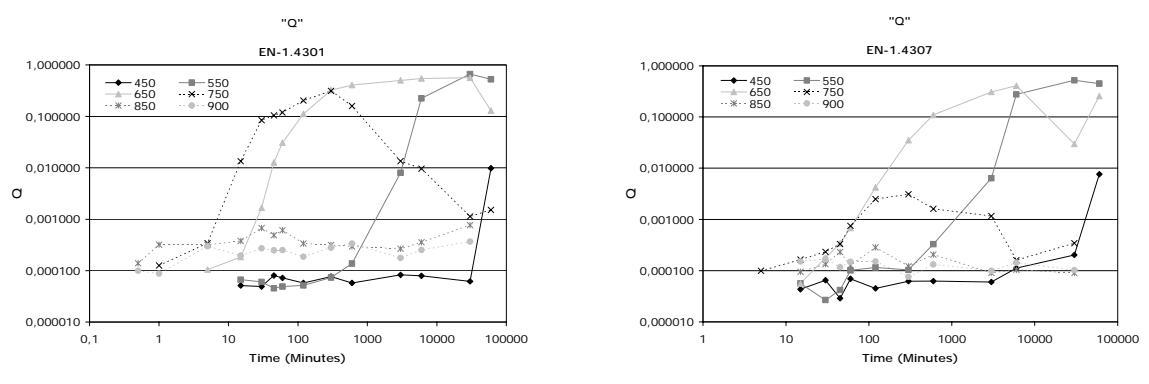
Figure 14. "Q" -EN 1.4307

The "Q" value obtained for all the thermal treatments for the both stainless steels are plotted in Figures 13 and 14.

and at 550°C the sensitization appears after 3000 minutes. In the case of low carbon stainless steel, it is observed that the most critical sensitization temperature is 650°C, followed by 550°C.

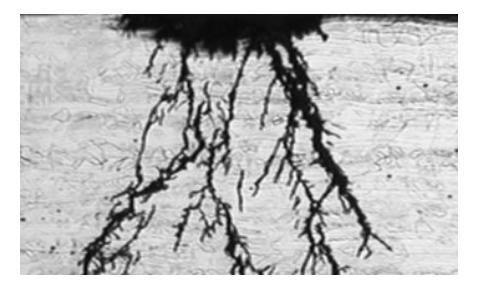
Figure 1. N 1.4404, MgCl_2, 30 %RH, 22 weeks, (width 440 $\mu m.$

Stress corrosion cracks were found on all specimens of grade EN 1.4301 and samples exposed for 22 weeks were cracked completely. Similar observations were made for more alloyed grade EN 1.4404, but the extent of SCC was lower. SCC of EN 1.4404 probably initiated from pits. In Figure 1, shows that the cracks were branched and transgranular as typical for SCC of stainless steels in chloride environments. Super austenitic grades EN 1.4539 and EN 1.4547 showed no SCC. However, the extent of pitting corrosion increased with time of exposure. No significant difference was seen in the performance of the two grades EN 1.4539 and EN 1.4547. Specimens of duplex EN 1.4162 were pitted after exposure. The pitting density was usually high and in some cases all surfaces were covered with pits. The pits were small and often elongated. The results of the metallographic examination did not confirm the presence of cracks and only shallow pits were identified. The duplex grades EN 1.4362, EN 1.4462, and EN 1.4410 were all corroded in a similar manner. All samples had shallow etched areas on the surface see Figure 2. However, the corrosion was deeper in some places and it rather had a character of pitting. The corrosion morphology was somewhat different for the materials. It was purely selective in case of EN 1.4362 and 1.4462 and pitting combined with partly selective dissolution of one phase for EN 1.4410. Using scanning electron microscope (SEM) with EDS analyzer, the corroded phase was in all cases identified as the ferritic phase. This phase appears darker in the images.

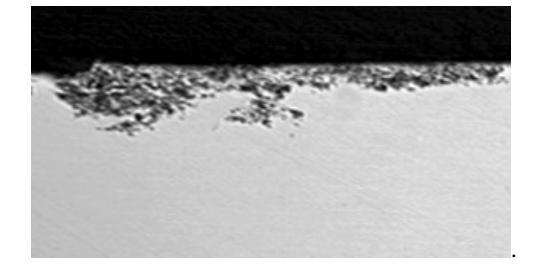
Figure 2. EN 1.4462, MgCl_2, 30 % RH, 22 weeks, (width 800 $\mu m)$

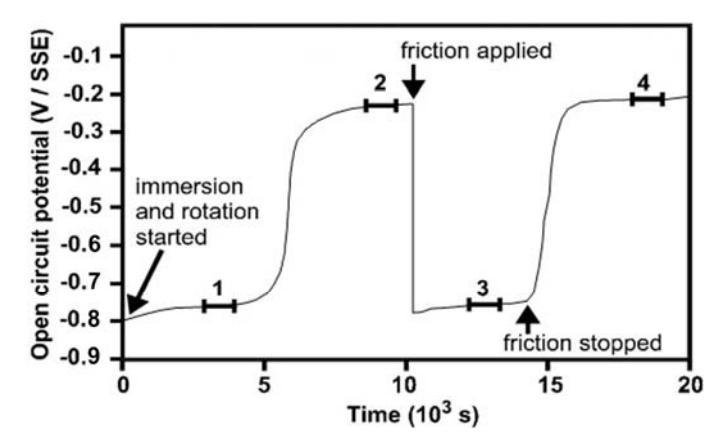
Figure 1. Evolution of the open circuit potential with immersion time of stainless steel in 0.5 M sulfuric acid before (periods 1 and 2), during (period 3), and after (period 4) continuous unidirectional sliding at a normal force of 5 N.

indicates that the passive film is removed by the mechanical interaction. Part of the wear track becomes active [4], and a galvanic couple is established between worn and unworn areas at the sample due to their different open circuit potentials (period 3 in Figure 1). At the time that sliding is interrupted or ended, the wear track progressively repassivates, and the increase of the open circuit potential indicates the re-growth of a passive surface film (period 4 in Figure 1).

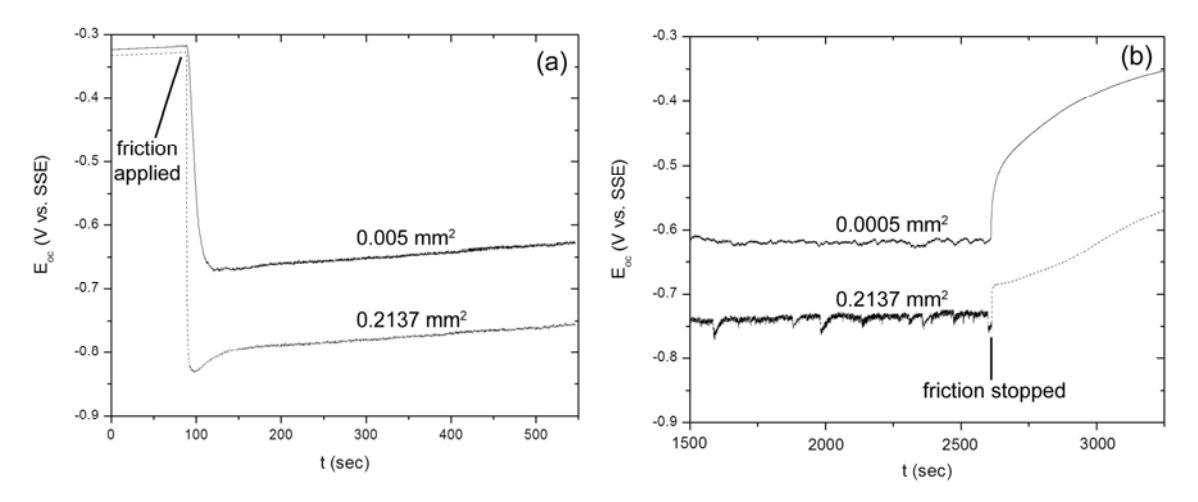
Figure 2. Evolution of the open circuit potential of stainless steel AISI316 immersed in 0.5 M sulfuric acid during (a) start up, and (b) final stage of continuous unidirectional sliding against zirconia performed under hertzian contact areas of either 0.0005 or 0.2137 mm^2 .

The evolution of the open circuit potential during continuous sliding was recorded under test conditions where two different contact areas were achieved on stainless steel immersed in a sulfuric acid aqueous solution, (Figure 2). Hereto the counter-body radii and the normal loads were varied so that an identical maximum contact pressure of 281 MPa was achieved in both cases but with hertzian contact areas of 0.0005 mm² and 0.2137 mm² respectively. The increased potential drop noticed reveals that the larger contact area results in a larger depassivated area. The fact that an identical contact pressure was achieved in both tests assures that the difference in open circuit potential noticed is caused only due to a varying ratio of active-to-passive area, and not to any mechanical effect (e.g. elasto-plastic deformation, induced phase transformation). The difference in wear track area size is clearly appearing from the SEM micrographs of the wear tracks after the sliding tests shown in Figure 3.

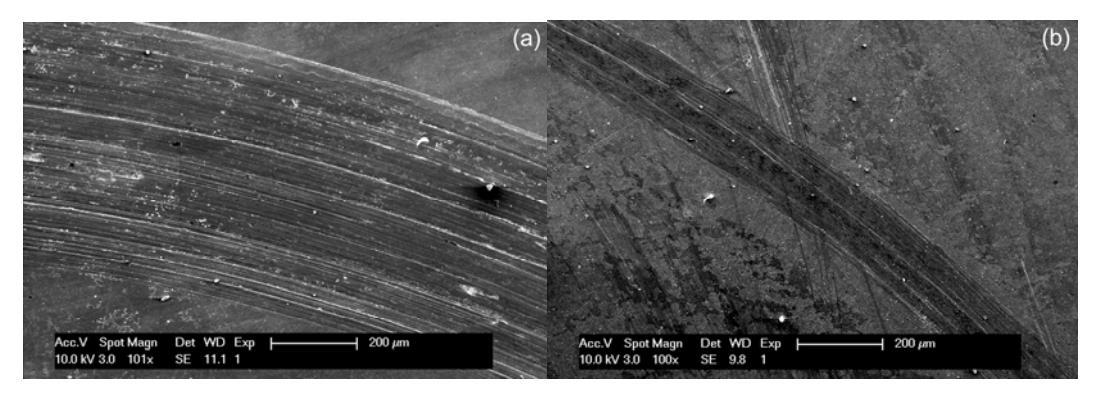
Figure 3. Scanning electron micrographs of stainless steel after continuous unidirectional sliding against zirconia in 0.5 M sulfuric acid performed for 2,700 cycles under hertzian contact areas of (a) 0.2137 mm², and (b) 0.005 mm².

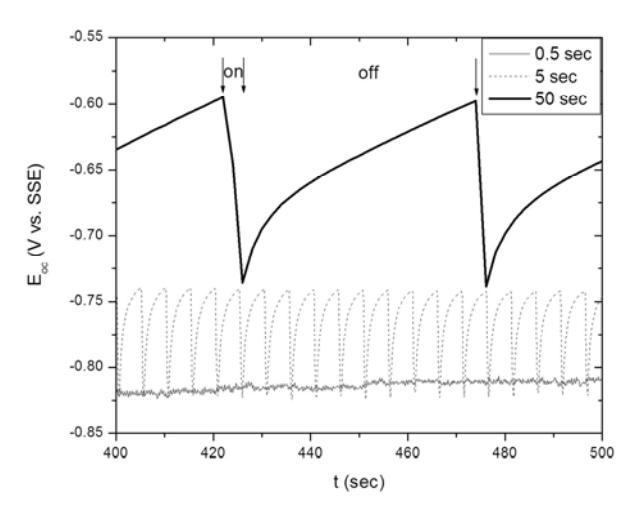
Figure 4. Open circuit potential evolution during continuous and intermittent unidirectional sliding of stainless steel AISI 316 against zirconia balls in 0.5 M sulfuric acid at a normal force of 5 N.

A zoom-in on the variation of the open circuit potential in period 3 (cf. Figure 1) recorded during continuous and intermittent unidirectional sliding tests performed at different latency times is shown in Figure 4. During continuous sliding tests at a latency time of 0.5 s, the open circuit potential is stable around -0.82 V vs. SSE. This potential is a mixed potential resulting from a dynamic equilibrium between active and passive areas inside and outside the wear track obtained under a constant rotation rate of the counter-body. During intermittent sliding tests performed at a latency time of 5 sec, the open circuit potential drops during sliding periods and rises during non-sliding periods, resulting in a fluctuation of the open circuit potential between -0.82 and -0.74 V vs. SSE. The drop of the open circuit potential reveals the removal of the passive layer. The progressive increase of E_{oc} during the period that the counter-body is immobile indicates the progressive re-growth of the passive film. At a latency time of 5 s, a dynamic equilibrium is not achieved since no potential plateau value is reached. A similar trend is noticed at a latency time of 50 sec but with open circuit potential fluctuations that are more pronounced, namely between -0.73 and -0.59 V vs. SSE. At increasing latency time, more time is thus given to the passive film to re-grow during non-sliding periods, and therefore the effect of the passive film thickness on the tribocorrosion of stainless steel is decoupled from the sliding speed.

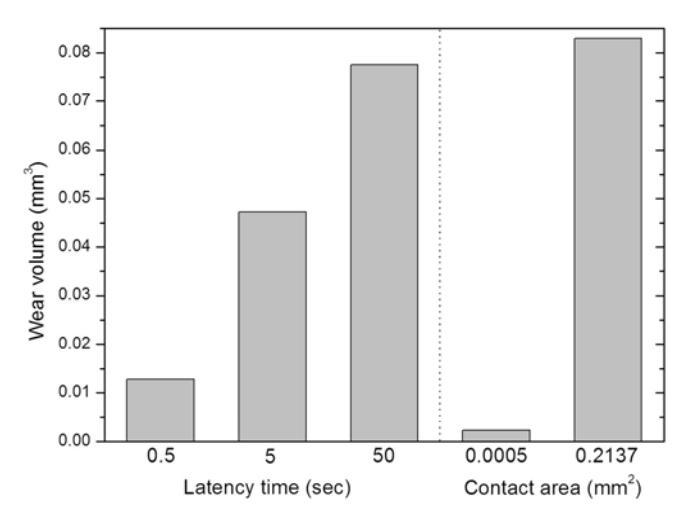
Figure 5. Effect of latency time (2700 cycles) and contact area (5000 cycles) on the wear volume on stainless steel after unidirectional sliding tests against zirconia balls in 0.5 M sulfuric acid.

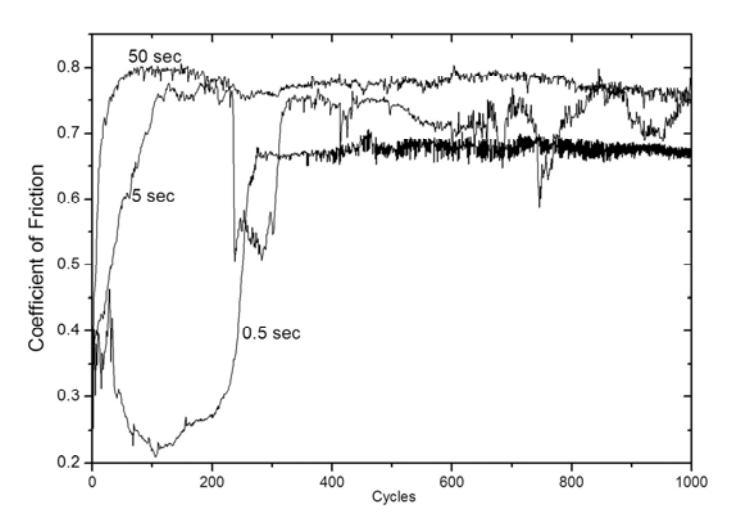
Figure 6. Evolution of the coefficient of friction recorded during continuous and intermittent unidirectional sliding tests on stainless steel AISI316 against zirconia balls immersed in 0.5 M sulfuric acid.

The evolution of the coefficient of friction with latency time is shown in Figure 6. It is noticed that after a running-in period, a coefficient of friction around 0.7 is measured at the different latency times. The running-in period decreases at increasing latency time indicating a dependence of the coefficient of friction on the latency time at short sliding durations.

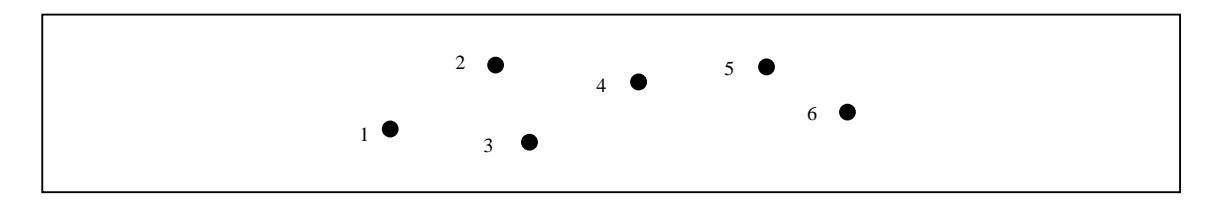
Figure 1. Example of areas showing discontinuity indications in ultrasonic studies

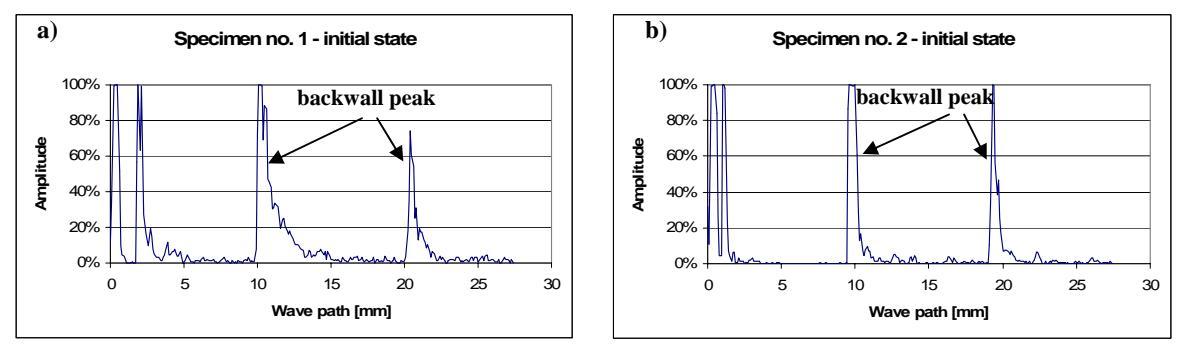
Figure 2. Ultrasonic wave spectra of specimens - initial state; a) specimen no. 1, b) specimen no. 2

The discontinuities at the interfaces were found based on the changes of in the amplitude signals. Examples of ultrasonic wave spectra for the examined specimens are shown in Figures 2-4. In accordance to ASTM A578 standard acceptable intensity of the peak derived from flyer-parent joint must not exceed 50% of the peak intensity derived from the specimen. This value was exceeded in none of the specimens, in spite of employing frequency higher than the standard. Hence, the results of ultrasonic testing proved a high quality of flyer-parent joints in the present study.

The signals derived from certain areas with a high echo intensity were also observed (Figures 2-4). A significant increase in the signal amplitude, reflected from the bonding interface, with the increase of the number of thermal cycles, was detected. This suggests the increase of discontinuities with the increase of trapped hydrogen.

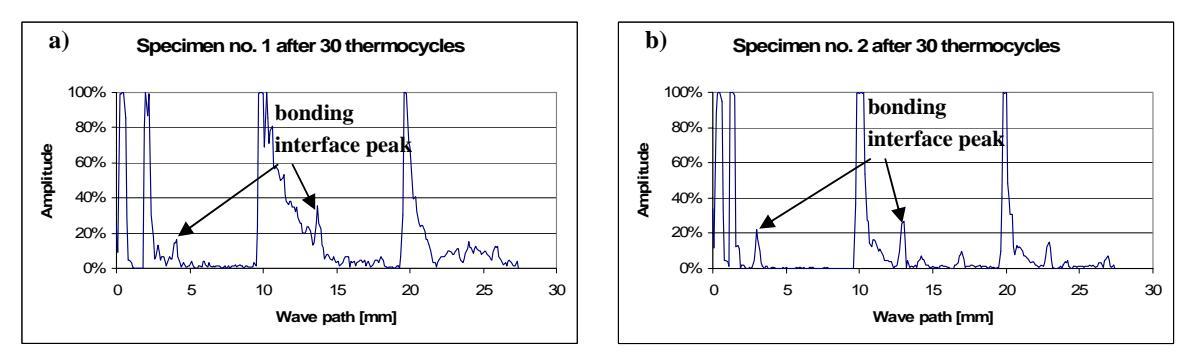
Figure 3. Ultrasonic waves spectra of specimens after 30T; a) specimen no.1, b) specimen no. 2

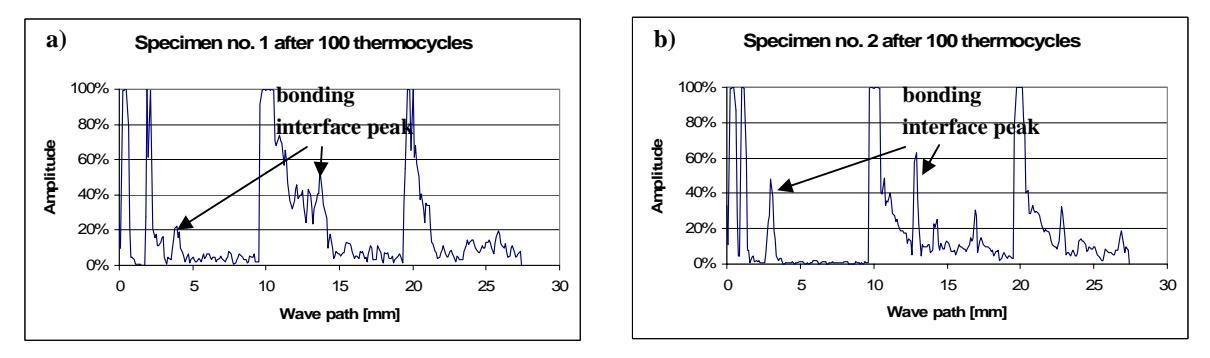
Figure 4. Ultrasonic wave spectra of specimens after 100T; a) specimen no. 1, b) specimen no. 2

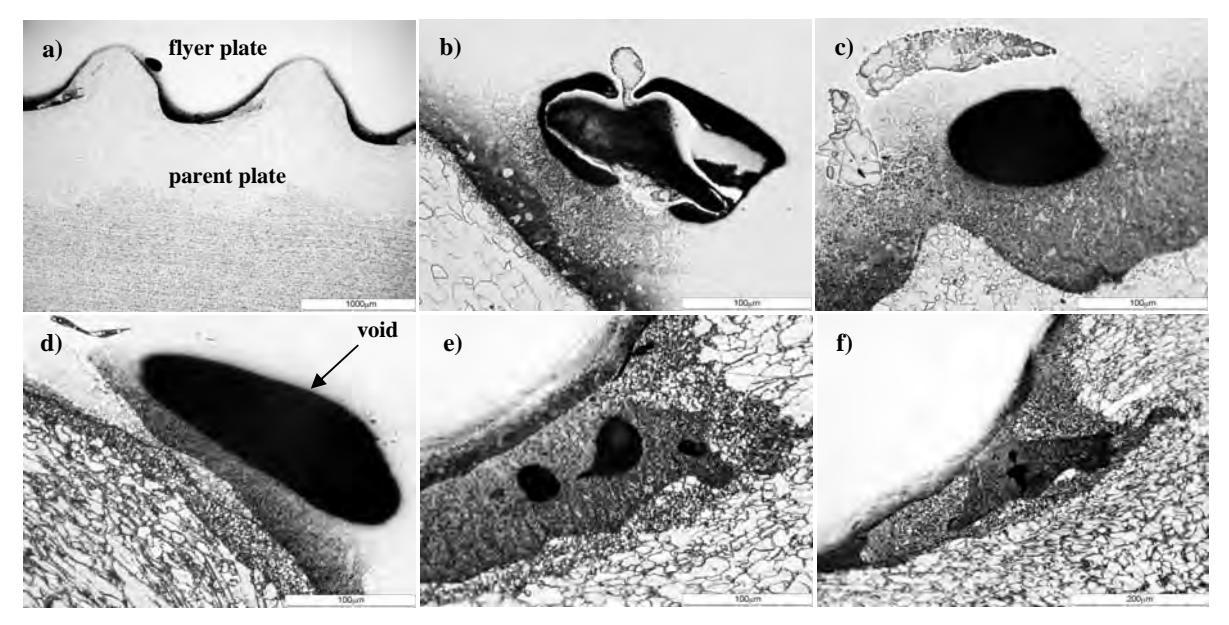
Figure 5. Microstructure of specimen no. 1: (a) - initial state; (b, c) - after 30T; (d, e, f) - after 100T

these locations are given in Figures. 5-6. Metallographic examinations on the cross sections of clad plates showed that the bonding interface has a typical wavy morphology [5], with local melted zones.

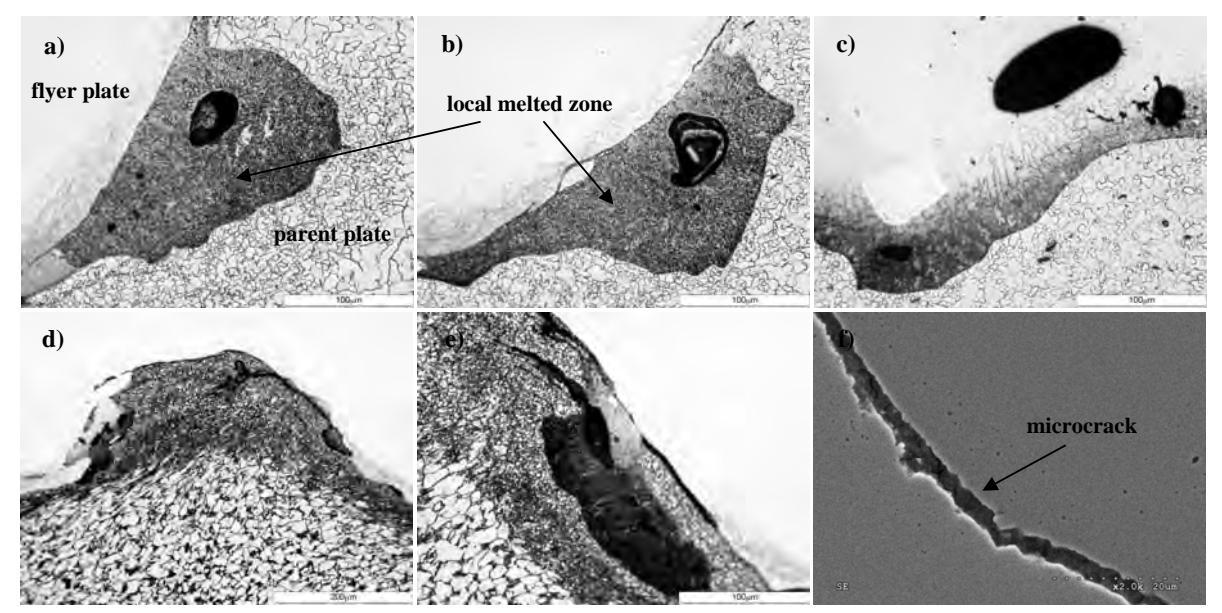
Figure 6. Microstructure of specimen no. 2: (a, b, c) – after 30T; (d, e, f) – after 100T; (f) – after 100T, SEM image

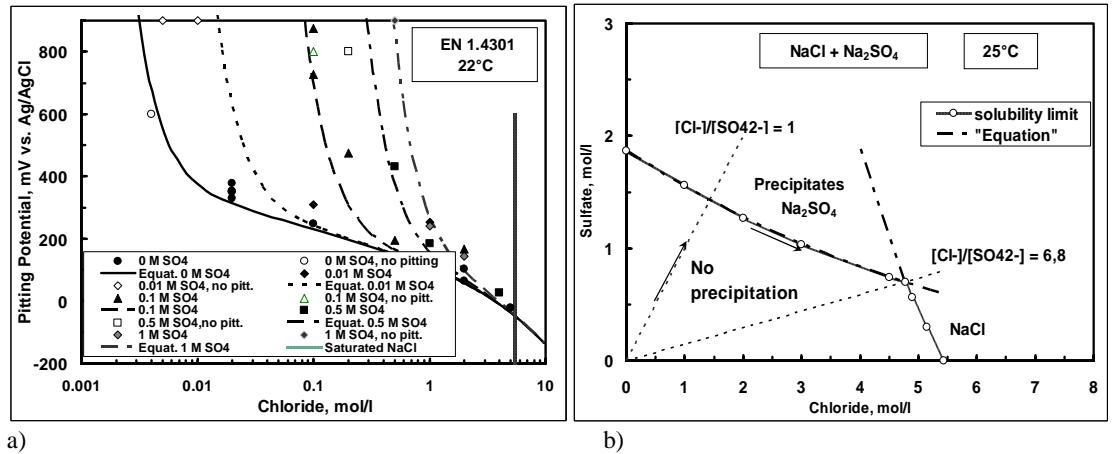
Figure 1. a) empirical model of pitting potentials of stainless steel EN 1.4301 in chloride-sulfate solutions b) Solubility limits for sodium sulfate and sodium chloride estimated by the ionic products of pure saturated salt solution.

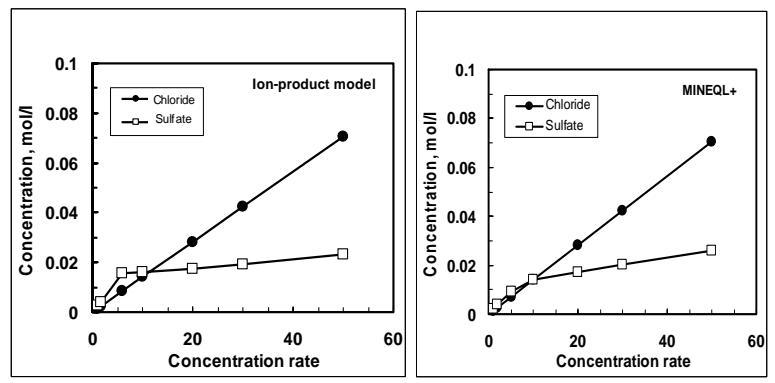
Figure 2. The concentrations of chloride and sulfate as a function of concentration rate calculated by ion-product model and by computer program Mineql+.

In the developed ion-product model, momentary ion products (without applying any activity coefficients) were compared with tabulated solubility products. In Figure 2. results provided by this model are compared with those by the MINEQL+. A significant correspondence between these two models prevails, indicating that the developed ion-product model can be applicable in practical cases. It is, however, strongly recommended that results of the ion-product model are regularly compared with results of simulation programs.

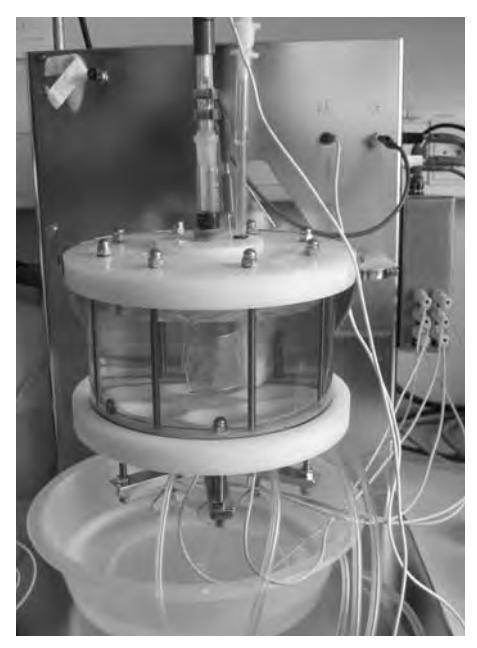
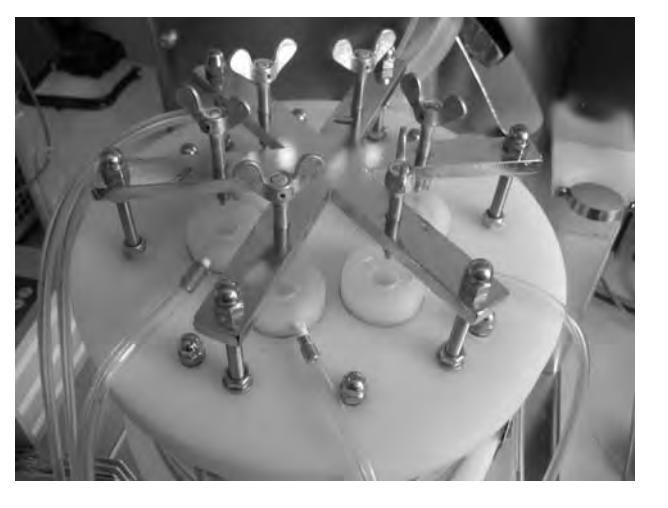
Figure 1. The Avesta multicell in operation (left). To facilitate sample mounting, the cell can be turned upside down (right).

adjusting the test temperature and electrolyte, this method can be adopted to suite a wide range of grades. The open circuit potential of the set of six samples was recorded for 15 minutes before sweep start from the open circuit potential. The scan rate was 10 mV·min⁻¹. When the current for a sample exceeded 1 mA·cm⁻², it was disconnected from the applied potential in order not to affect the others. The criterion for pit initiation was set to 100 μ A·cm⁻² for a duration of at least 60 seconds; the time criterion was imposed to filter out metastable pitting events. All potentials given in this paper are referenced to the Ag/AgCl reference electrode with a standard potential of 222.4 mV_{SHE} at 25 °C. The solution was deaerated with nitrogen gas during the entire experiment. All values reported are averages recorded on at least six samples.

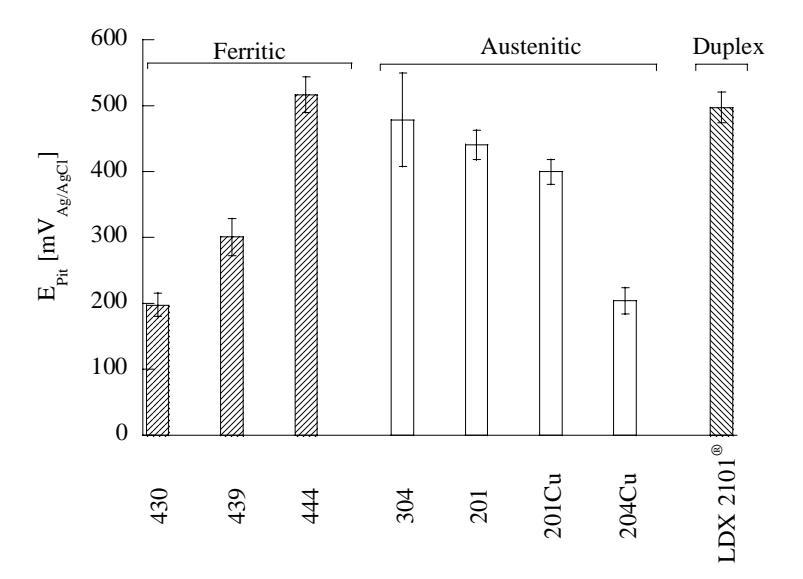
Figure 2. Average pitting potentials measured with the Avesta multicell. Error bars estimates a 95% confidence interval (2σ) and are based on at least six measurements. The results for the two different lots of 430 are presented as one bar.

[444, 304, LDX 2101[®]] > [201, 201Cu] > 439 > [430, 204Cu]

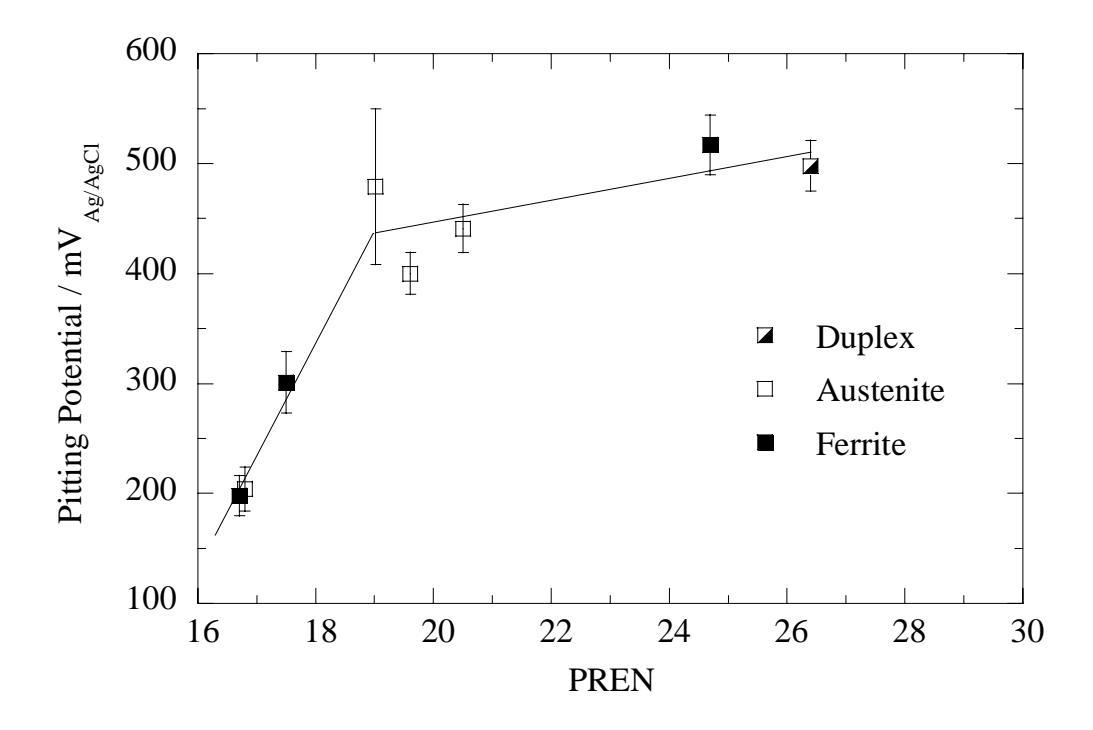
Figure 3. Pitting potentials as a function of the pitting resistance equivalent number (PREN).

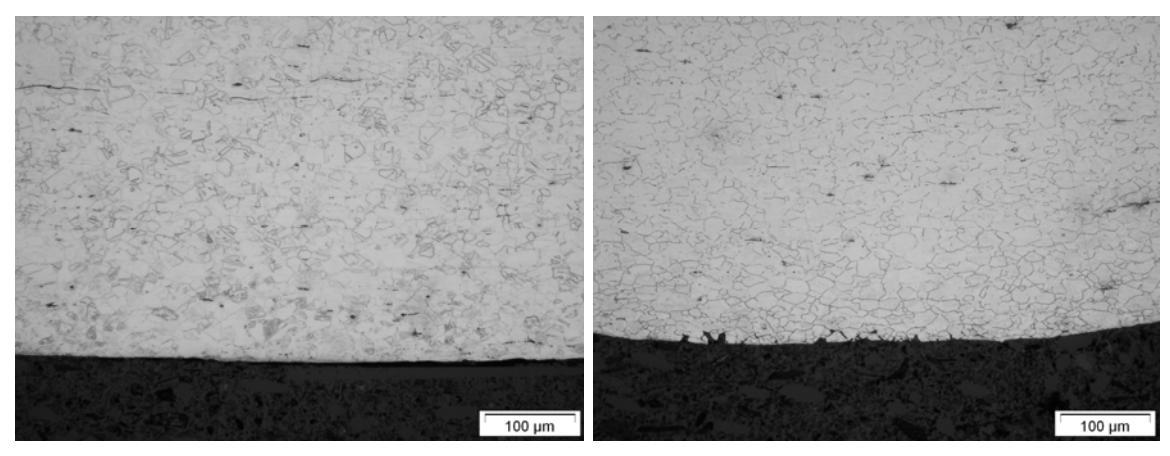
Figure 1 (left). Metallographic picture of a bent 1.4376 sample, annealed in a salt bath of 700°C for 6 min Figure 2 (right). Metallographic picture of a bent 1.4376 sample, annealed in a salt bath of 650°C for 60 min

The corrosive attacks observed by optical microscopy were classified into four degrees. The first does hardly reveal any attack (Figure 1). In the second case, several grains are partly dissolved at the surface, however definite intergranular corrosion (IGC) attack cannot be corroborated (Figure 2). Figure 3 gives an example of stronger corrosion attack (of about 50 to 100 μ m depth) along the grain boundaries which can clearly be interpreted as IGC. The most pronounced degree of corrosion is shown in Figure 4 with an attacking depth of at least 100 μ m.

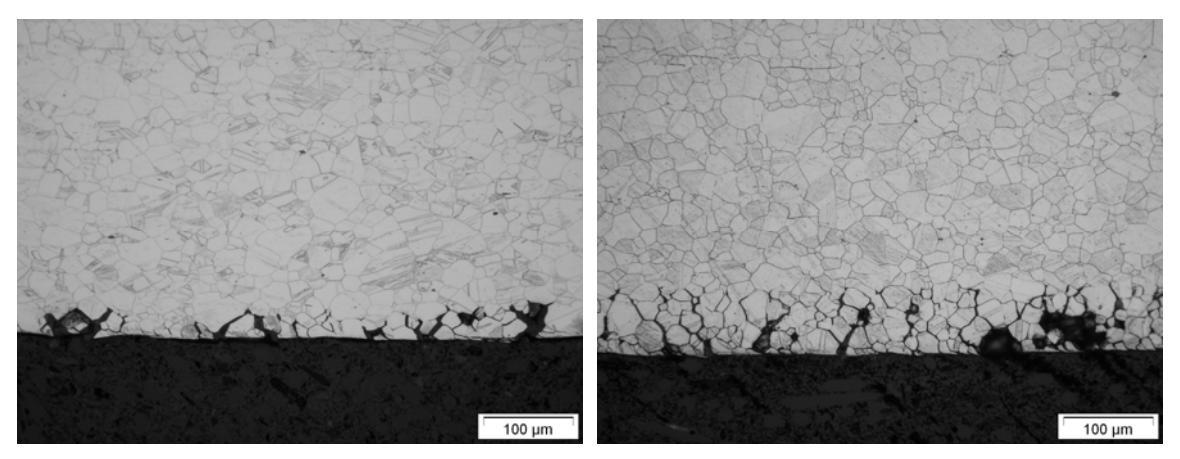
Figure 3 (left). Metallographic picture of a bent 1.4301 sample, annealed in a salt bath of 700°C for 60 min Figure 4 (right). Metallographic picture of a bent 1.4301 sample, annealed in a salt bath of 650°C for 60 min

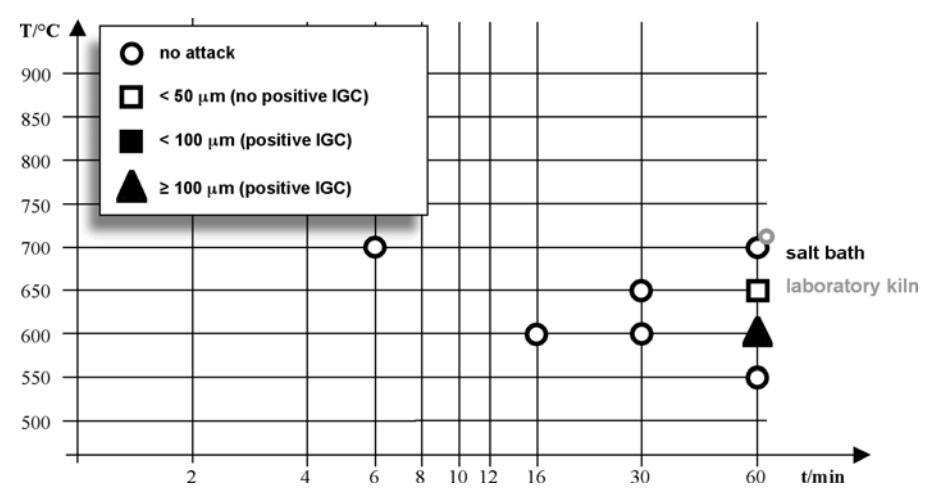
Figure 5. Influence of annealing time and temperature on the sensitization behaviour of 1.4376

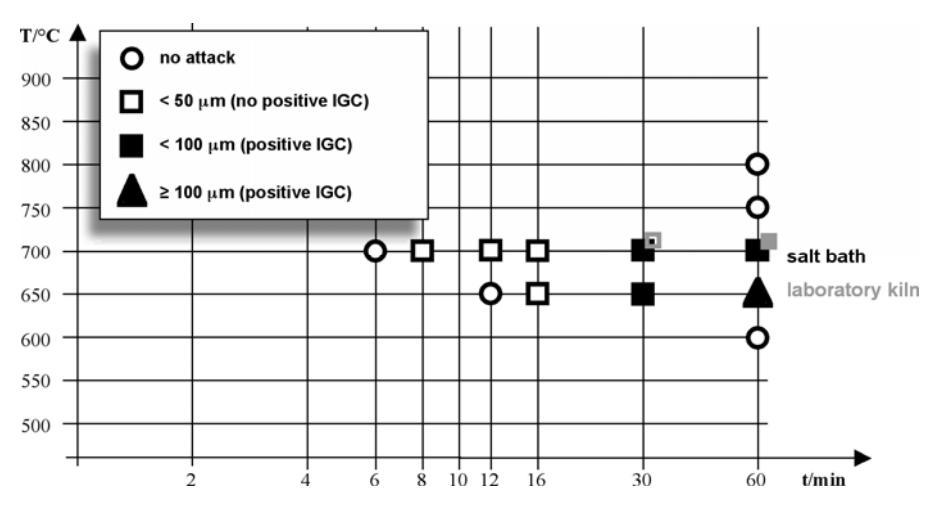
Figure 6. Influence of annealing time and temperature on the sensitization behaviour of 1.4301

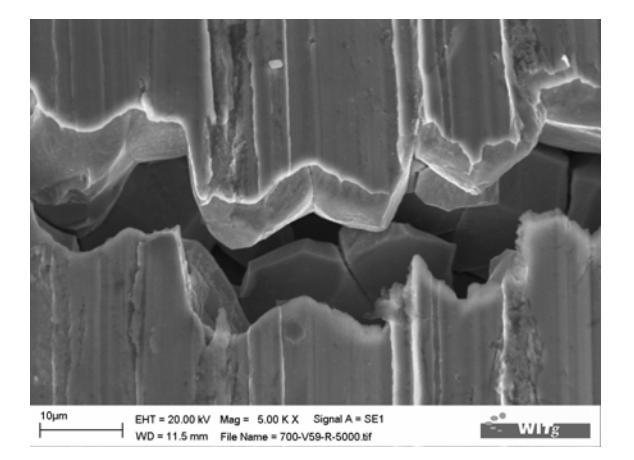
Figure 7. Surface of a bent 1.4301 sample, annealed in a salt bath of 700°C for 60 min (SEM, 5000x)

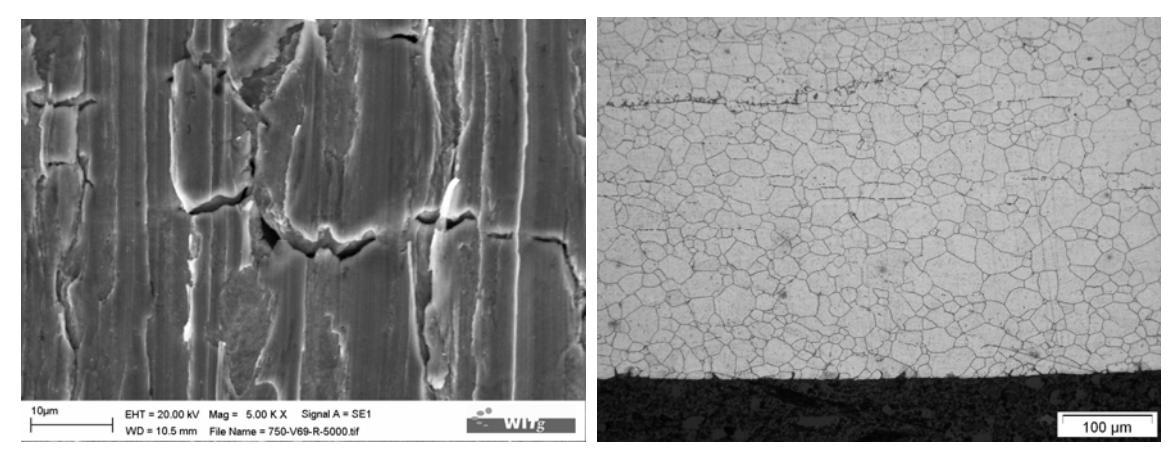
Figure 8 (left). Surface of a bent 1.4301 sample, annealed in a salt bath of 750°C for 60 min (SEM, 5000x) Figure 9 (right). Metallographic picture of a bent 1.4301 sample, annealed in a salt bath of 750°C for 60 min

along the surface detected by SEM (Figure 8), as only marginal surface attack is demonstrated by the respective metallographic analysis (Figure 9).
